Westinghouse Astronuclear Laboratory

WANL-TNR-224

NRX-A6 FINAL REPORT

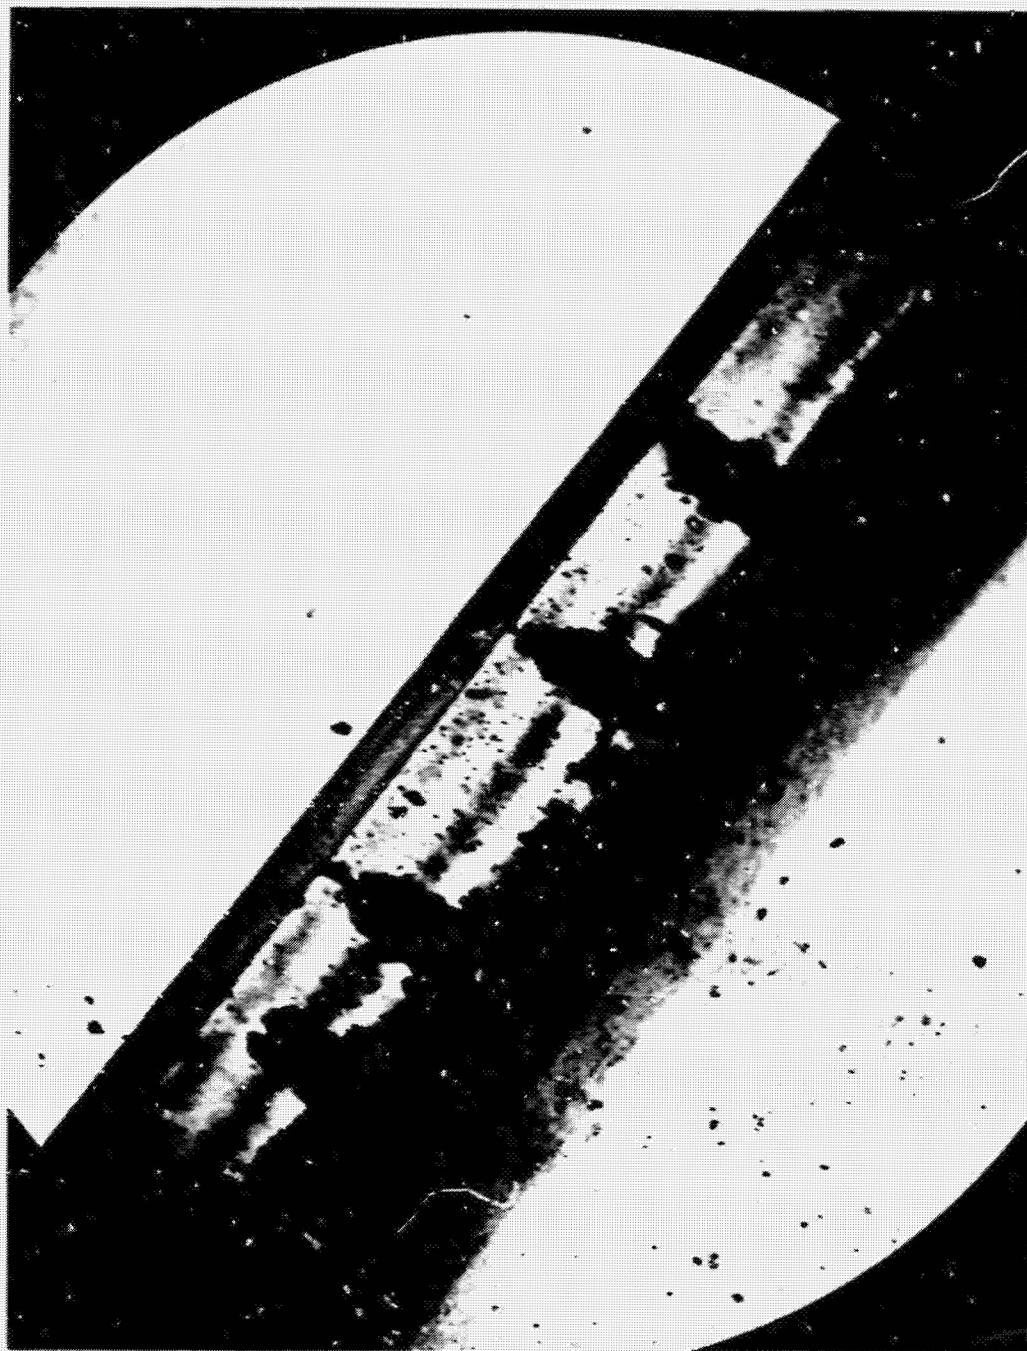
Figure 5-39. (CRD) NRX-A6 Fuel Element "Notch" Corrosion (U)

(CRD) Notch-type corrosion patterns similar to those observed on peripheral NRX-A5 elements were again observed on the peripheral faces of some NRX-A6 peripheral elements, although the fraction of peripheral NRX-A6 elements affected was lower. The post test analysis on the peripheral fuel elements show that this notching was due to high thermal stresses at the peripheral corners of certain fuel elements. This high thermal stress occurred during startup and was due to the combined effects of the heat flow from the core to the hot buffer filler strips and unfueled partial elements, and the cooling effect of a high leakage flow between the filler strips at locations where shifting of the element filler strips created large flow gaps.

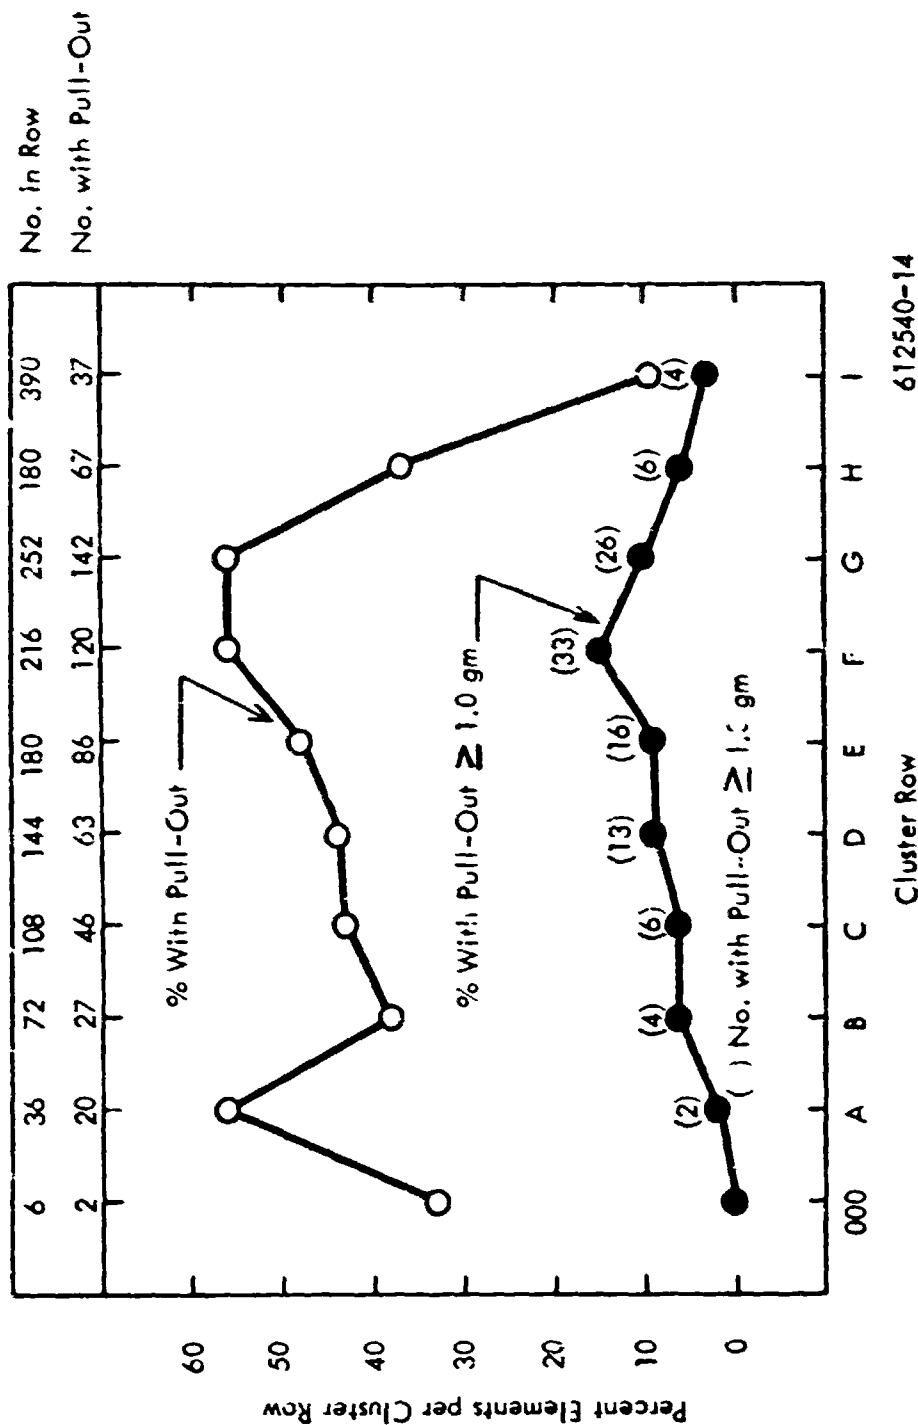
Figure 5-40. (CRD) Radial Distribution of NRX-A6 Fuel Element Pull-Out (U)

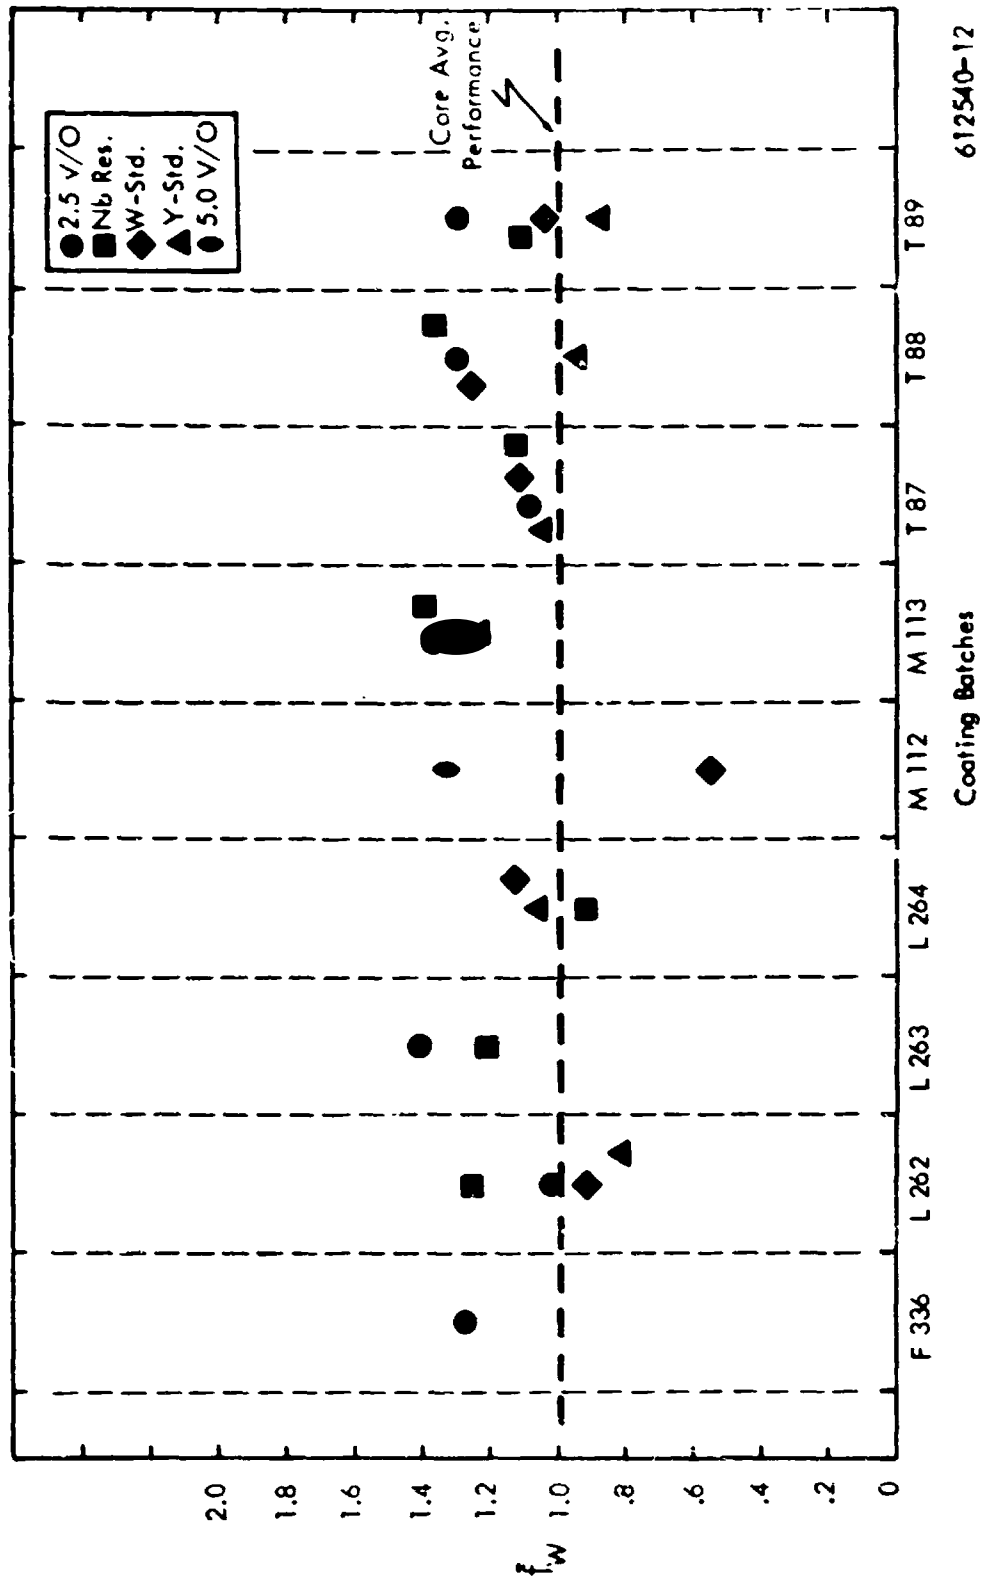
612540-12

Figure 5-42. (CRD) Weight Loss Index of Performance Estimate for NRX-A6 Experimental Fuel Elements (U)

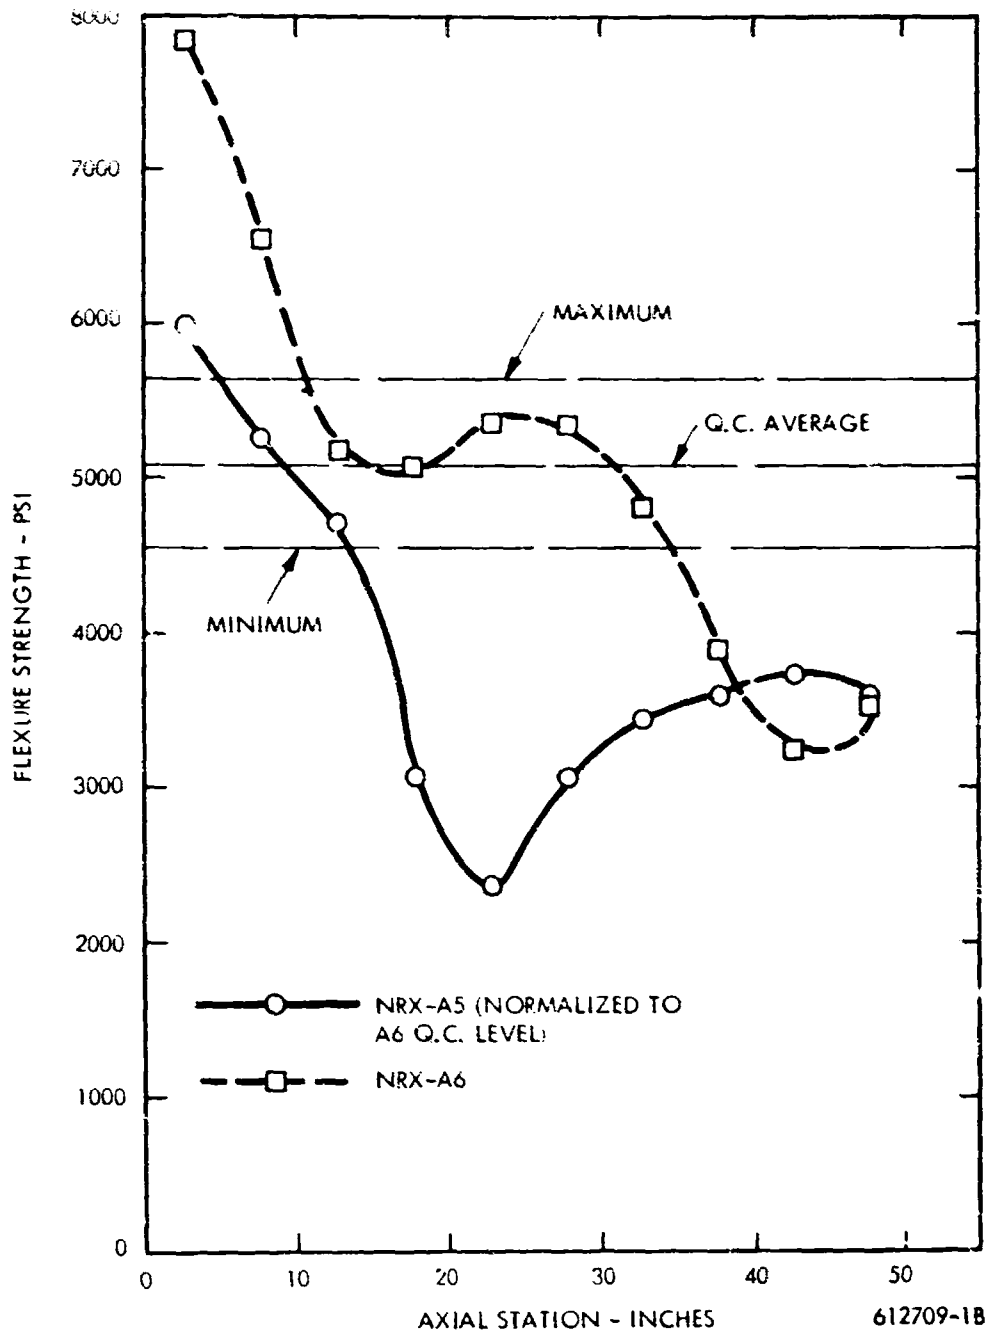
Figure 5-43. (CRD) Core Average Axial Variation in Flexure Strength for 79 NRX-A6 and 63 NRX-A5 Fuel Elements (U)

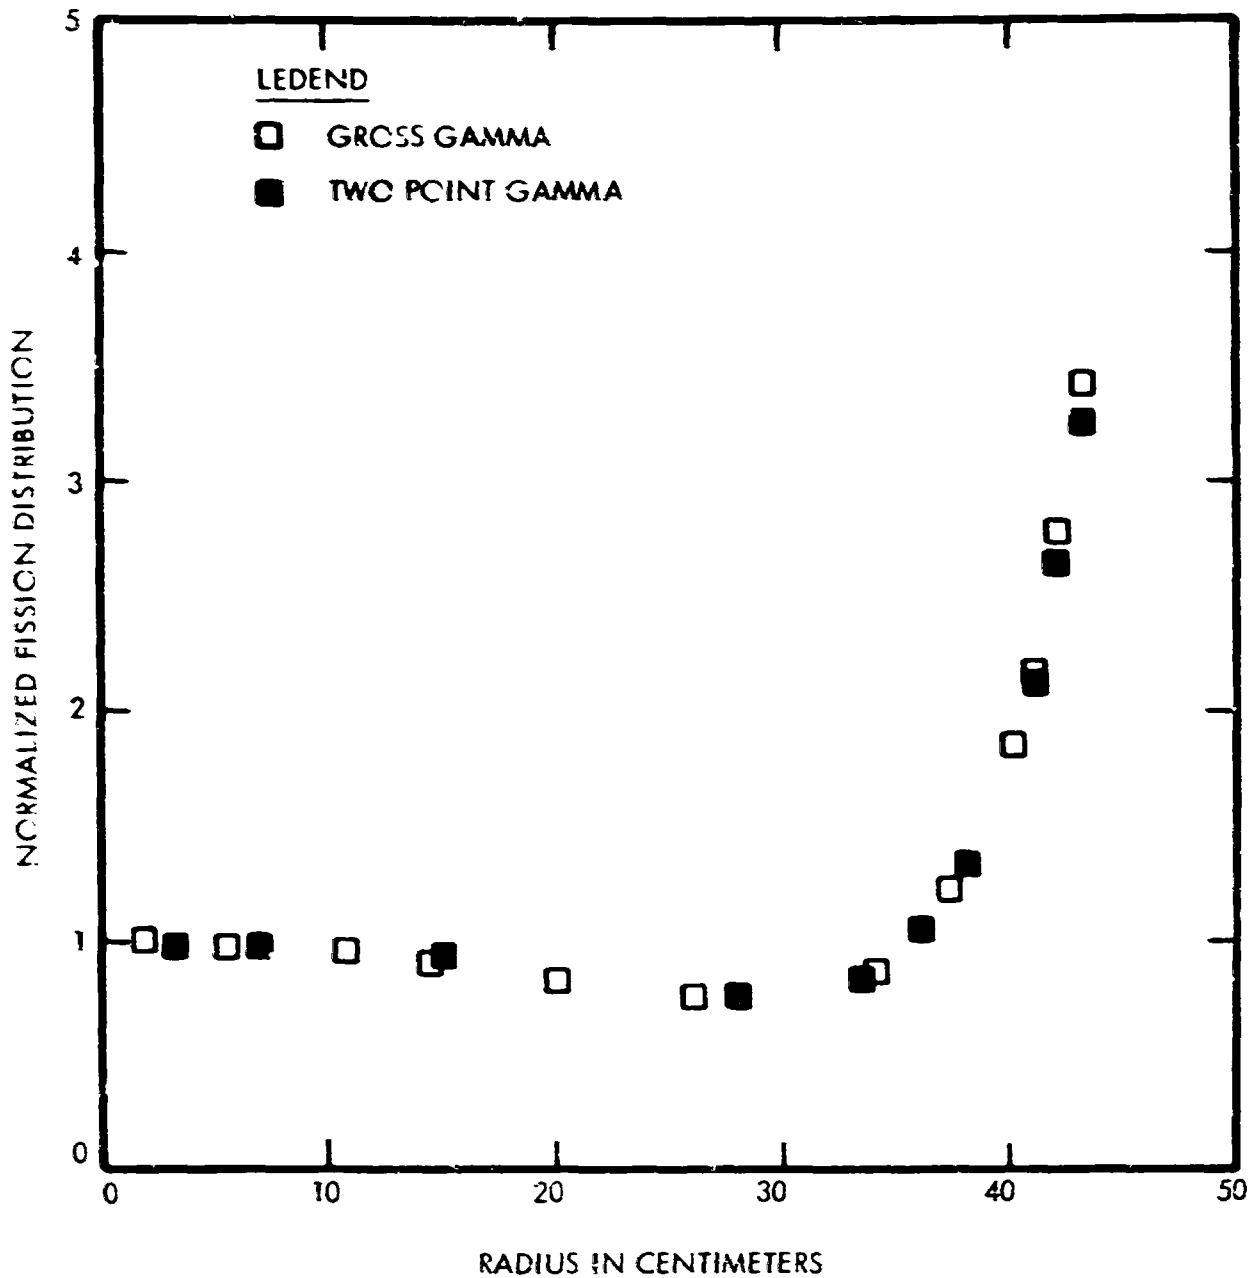
Figure 5-44. (CRD) Comparison of Gross Gamma and Two Point Gamma Radial Fission Distribution (U)

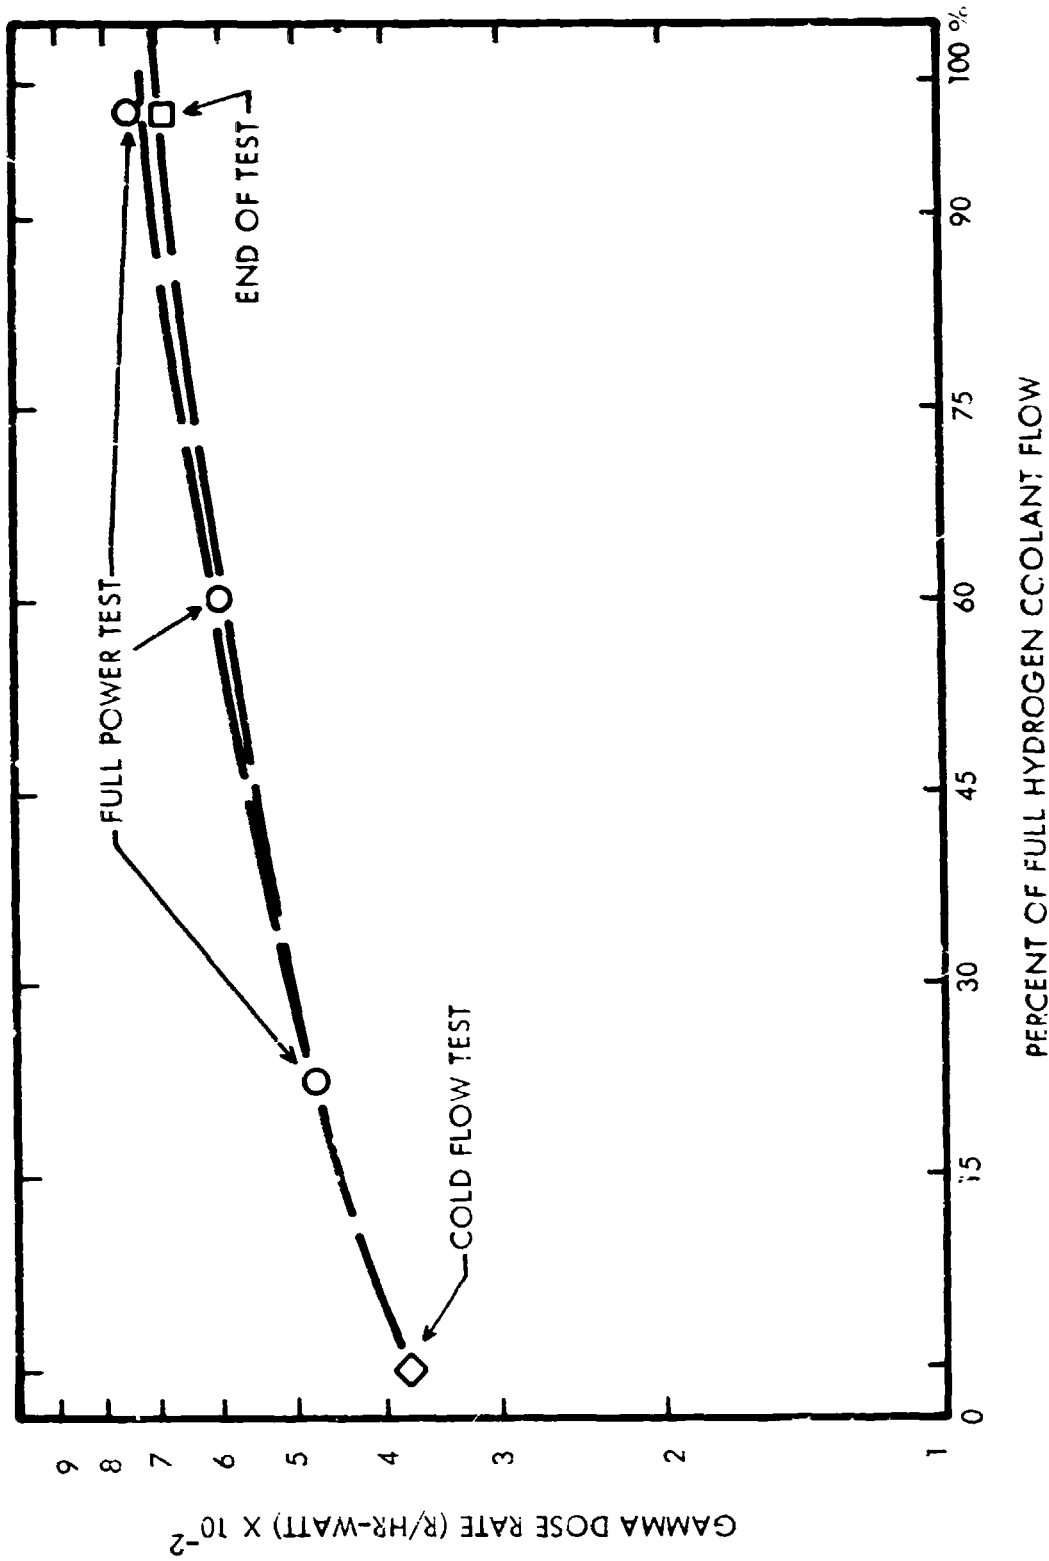
Figure 5-45. (U) Measured Gamma Dose Rate on the Privy Roof as a Function of Hydrogen Coolant Flow for the NRX-A6 Reactor (U)

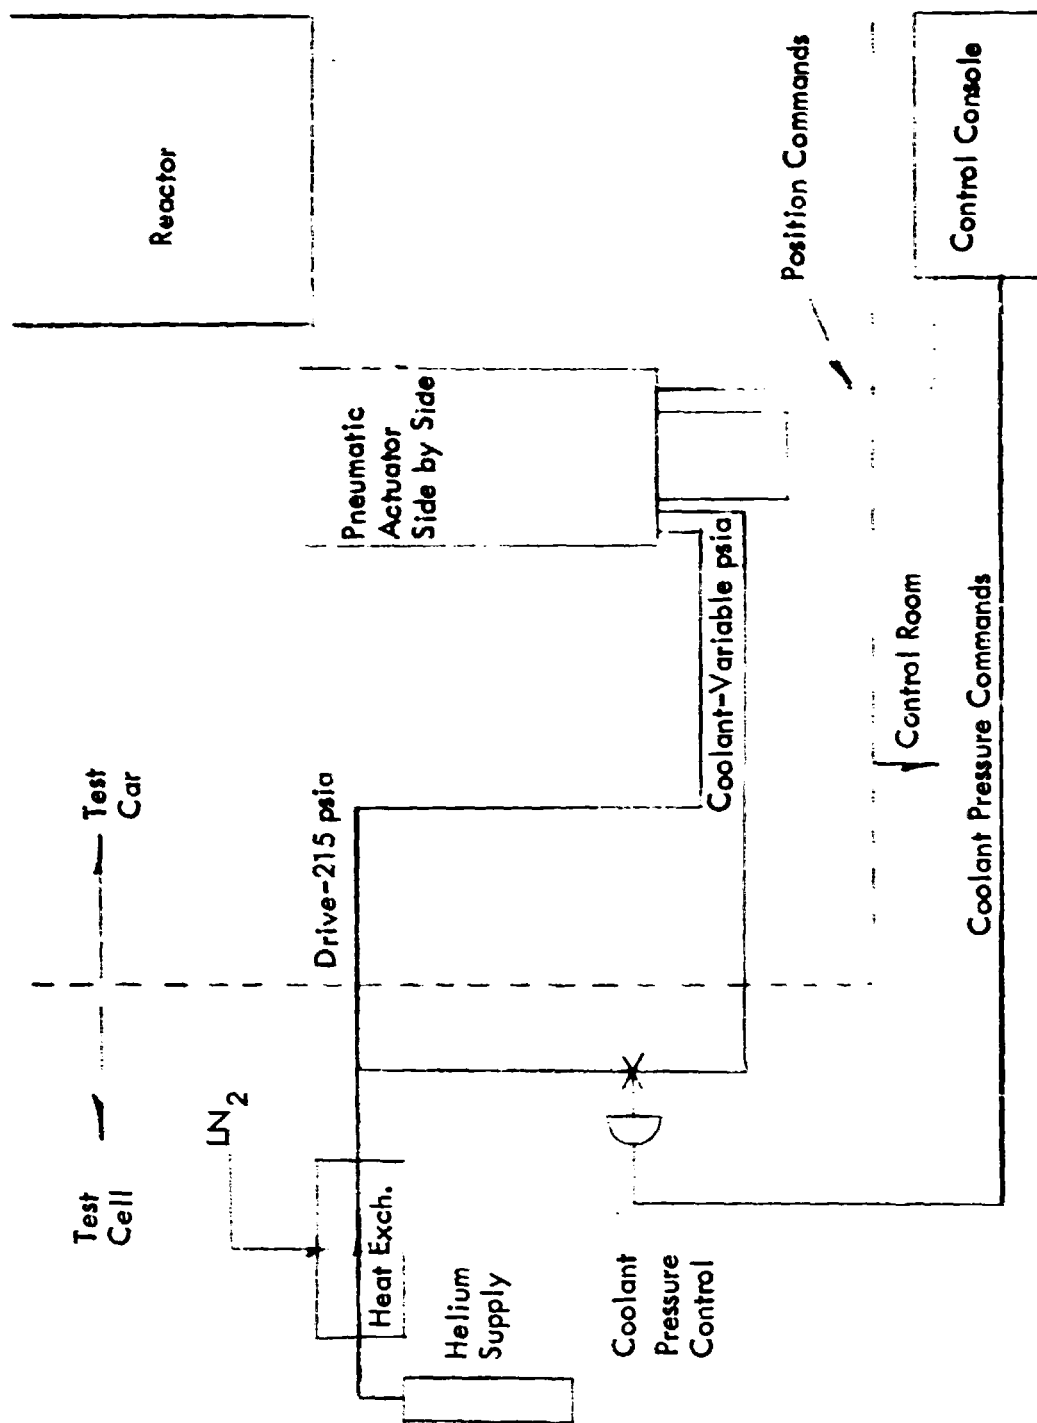
Figure 5-46. (U) Block Diagram of NRX-A6 Side-by-Side Actuator Test Setup

control room and were varied during the test by the side-by-side Test Operator. The actuator experiment was mounted on the test car inside the 360 degree shield next to the reactor at the $\theta = 180$ degree position. The position of the pneumatic actuator side-by-side experiment with respect to the NRX-A6 reactor is shown in Figure 5-47. Figure 5-48 is a drawing of the actuator, pedestal and a simulated drum load enclosed in its housing.

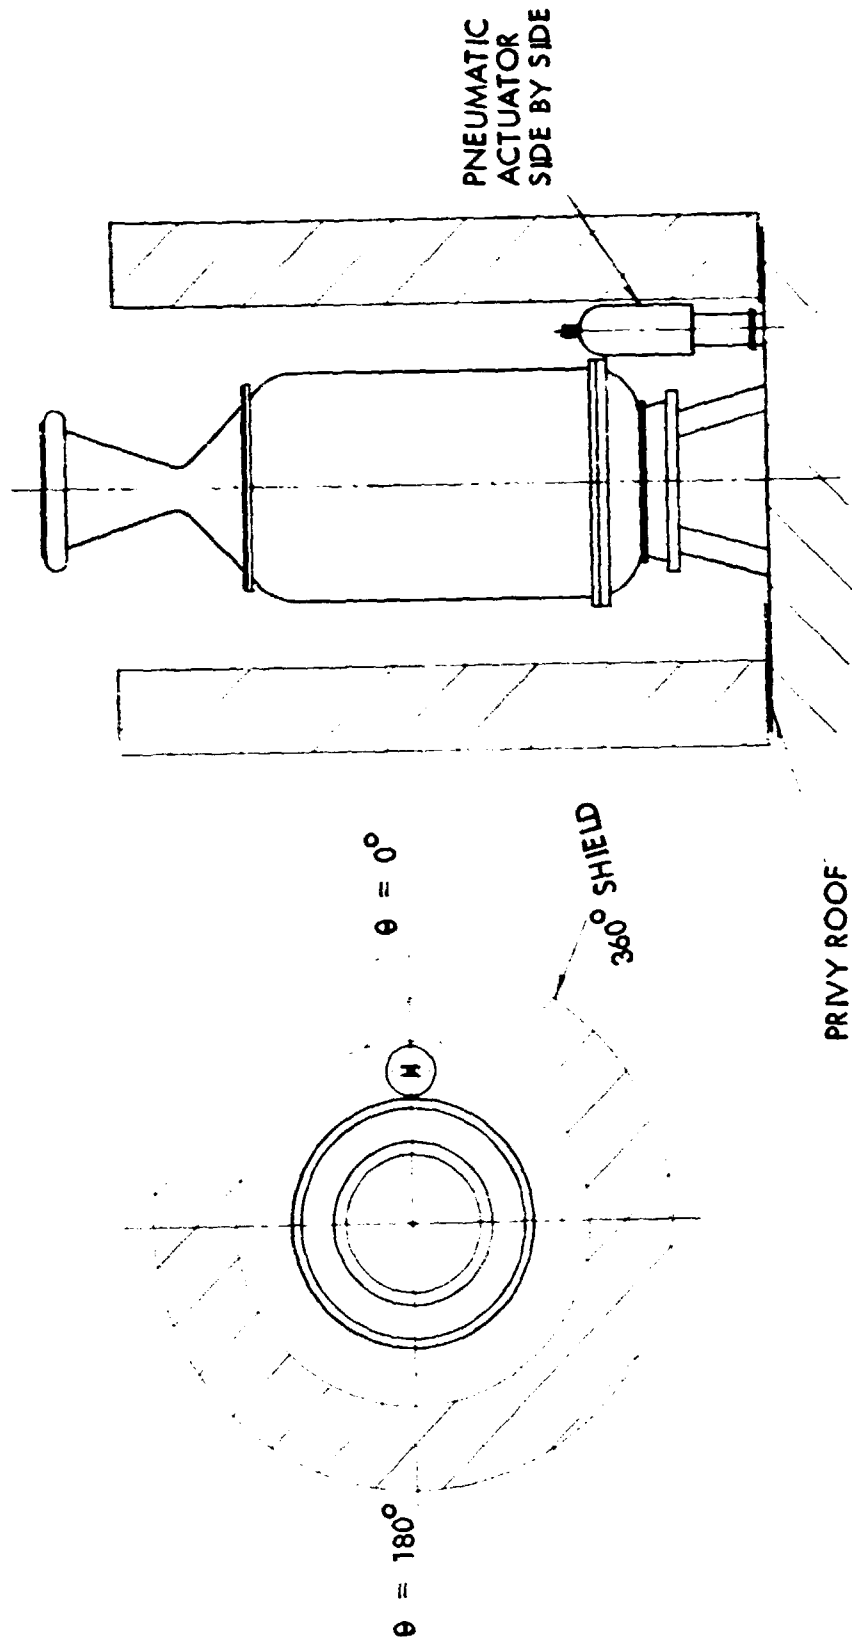
Figure 5-47. (U) NRX-A6 Side-by-Side Actuator Test Position Diagram

- 1) Coolant Pressure
- 2) Drive Pressure
- 3) Cylinder No. 1 Pressure
- 4) Cylinder No. 2 Pressure
- 5) Exhaust Pressure

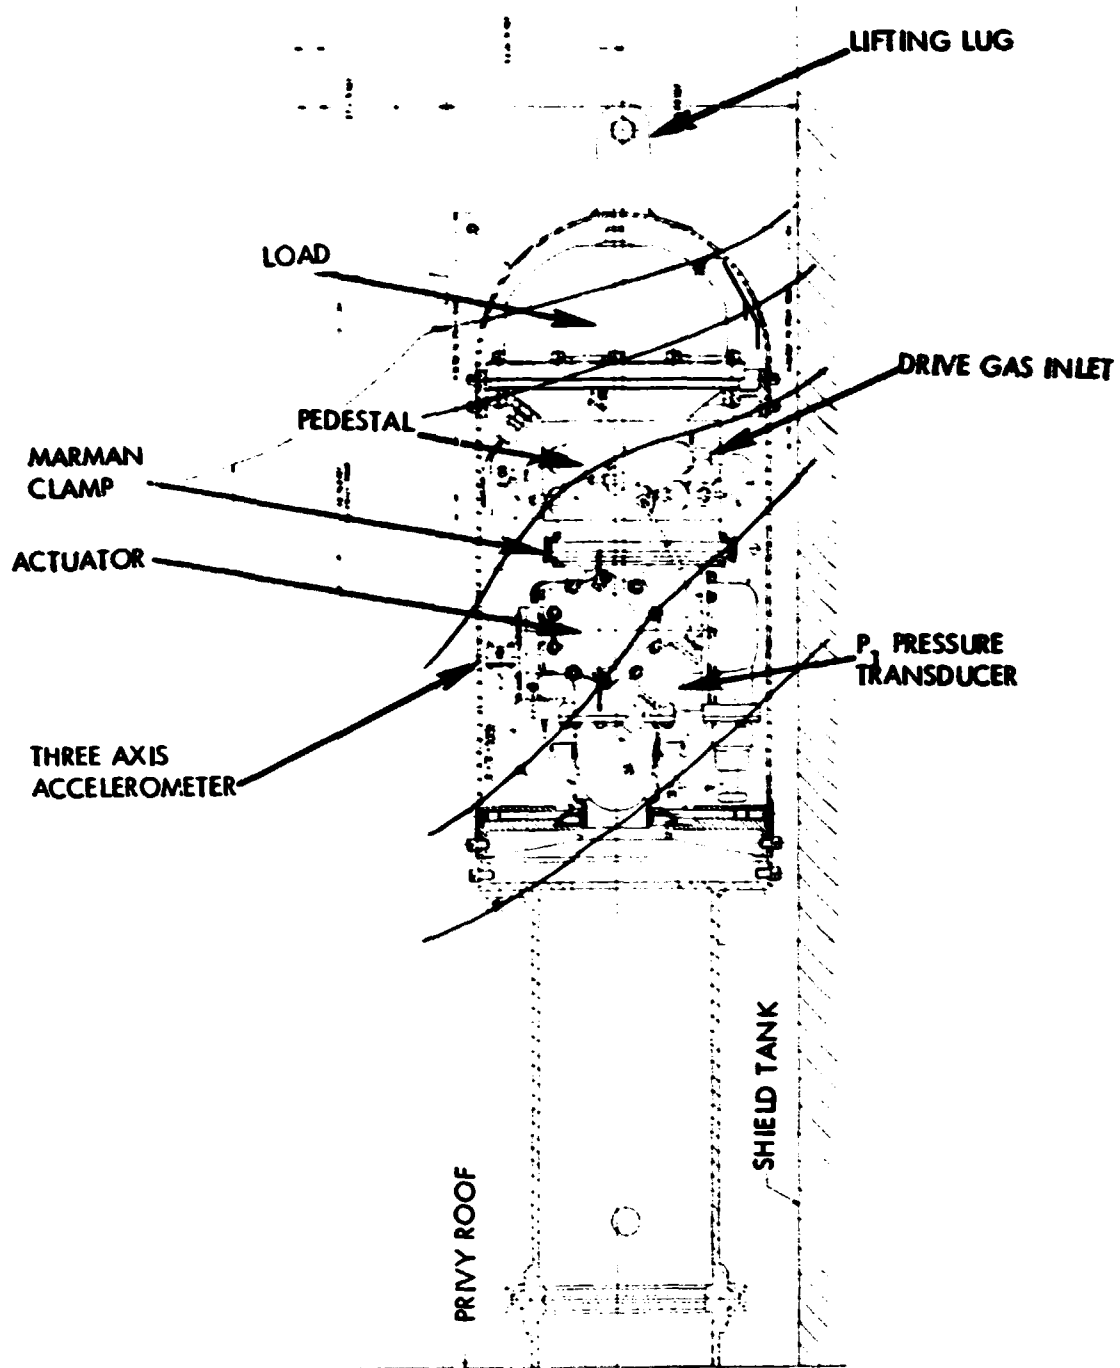
Figure 5-48. (U) Actuator, Pedestal and Simulated Drum Load

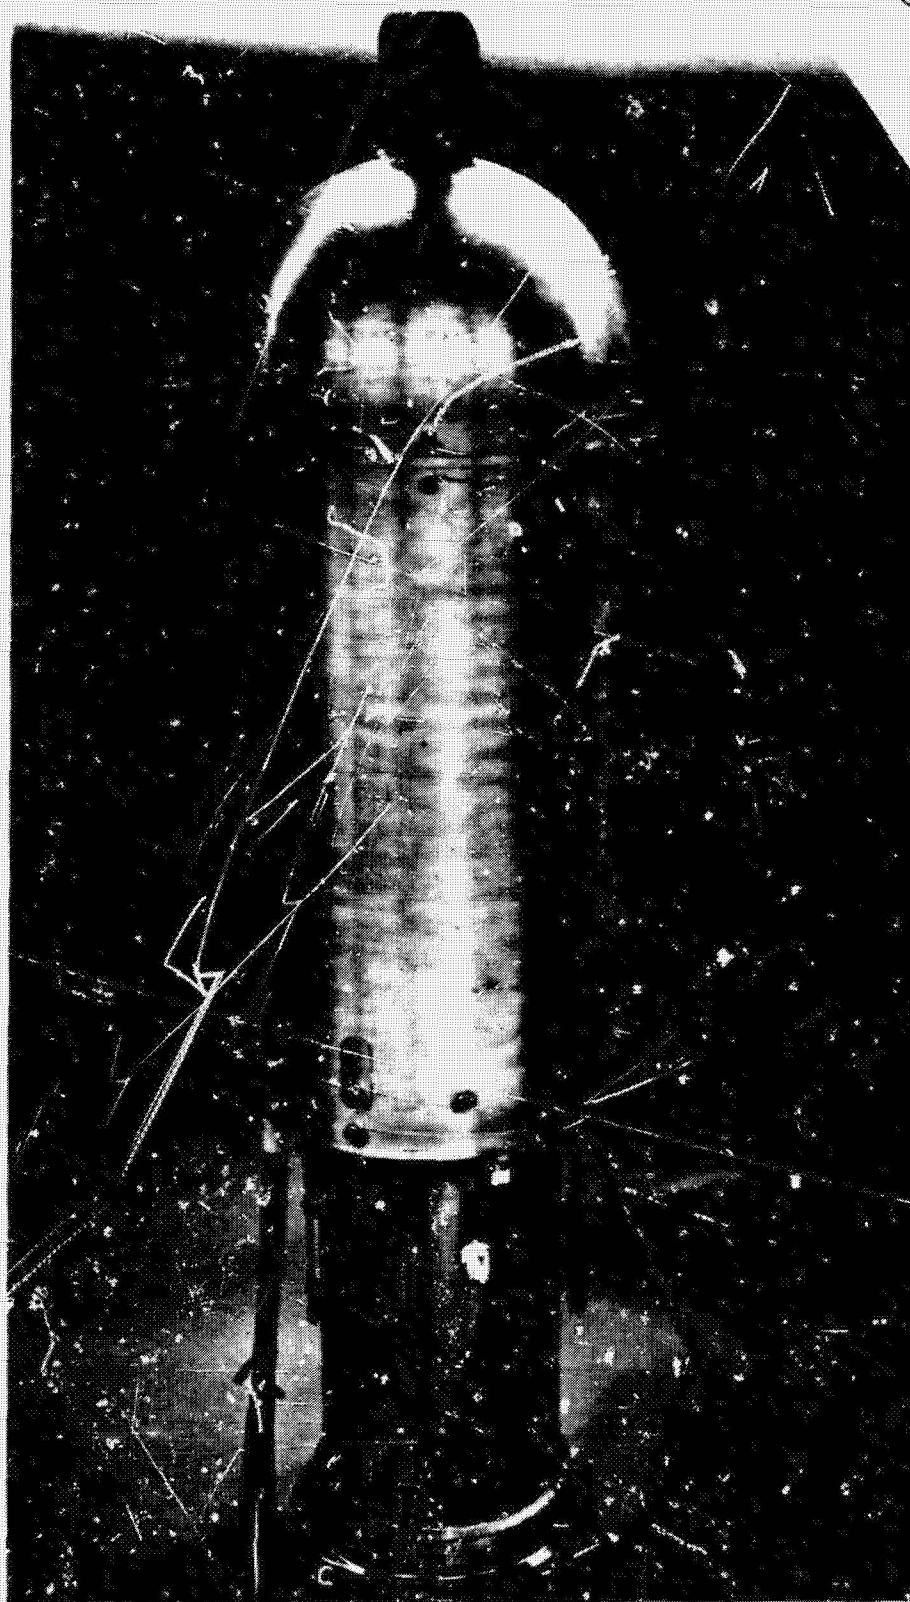
Figure 5-50. (U) Completely Assembled NRX-A6 Side-by-Side Actuator Test Assembly

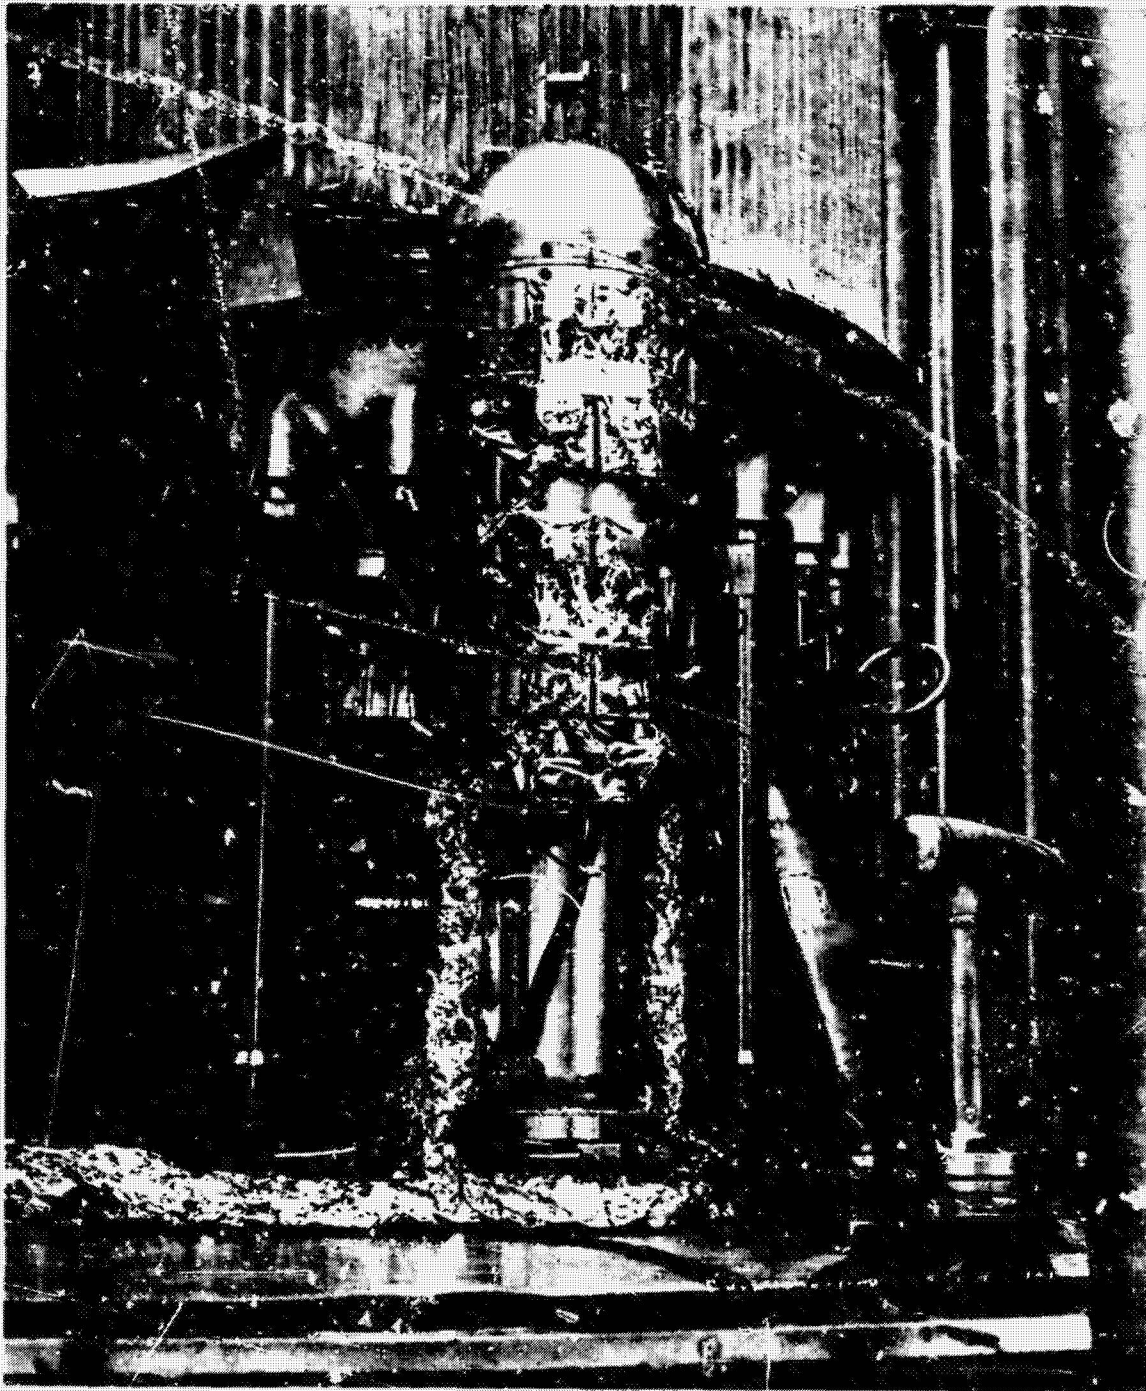
Figure 5-51. (U) NRX-A6 Side-by-Side Actuator Test
Assembly Mounted on Test Car

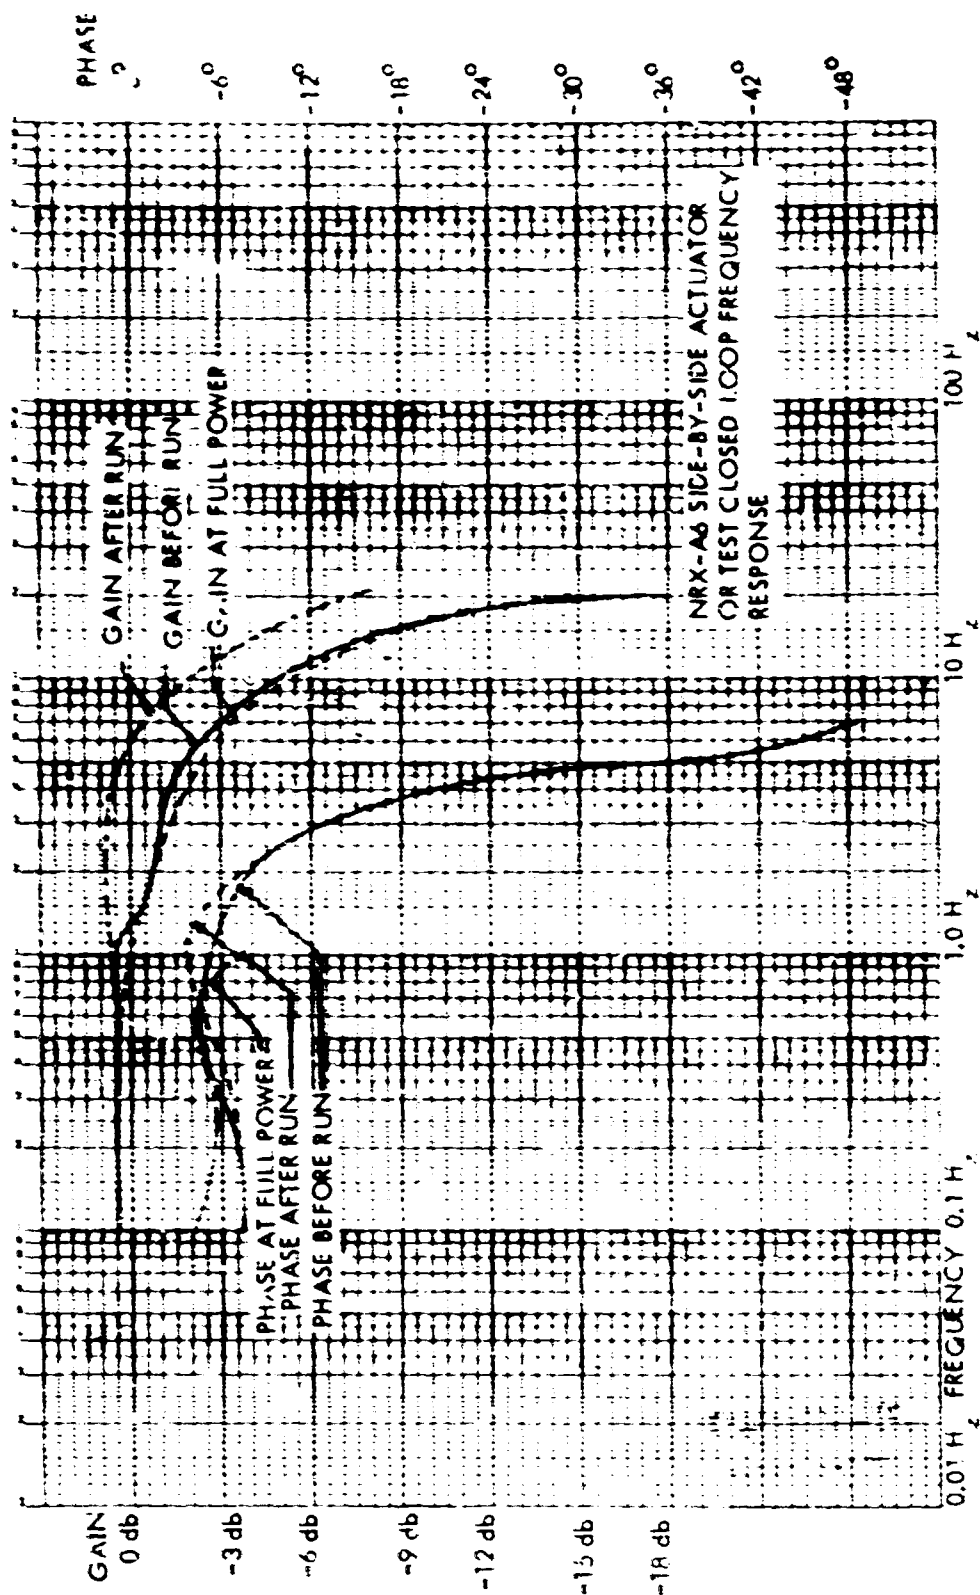
Figure 5-52. (U) Side-By-Side Actuator Test Closed Loop Frequency Response

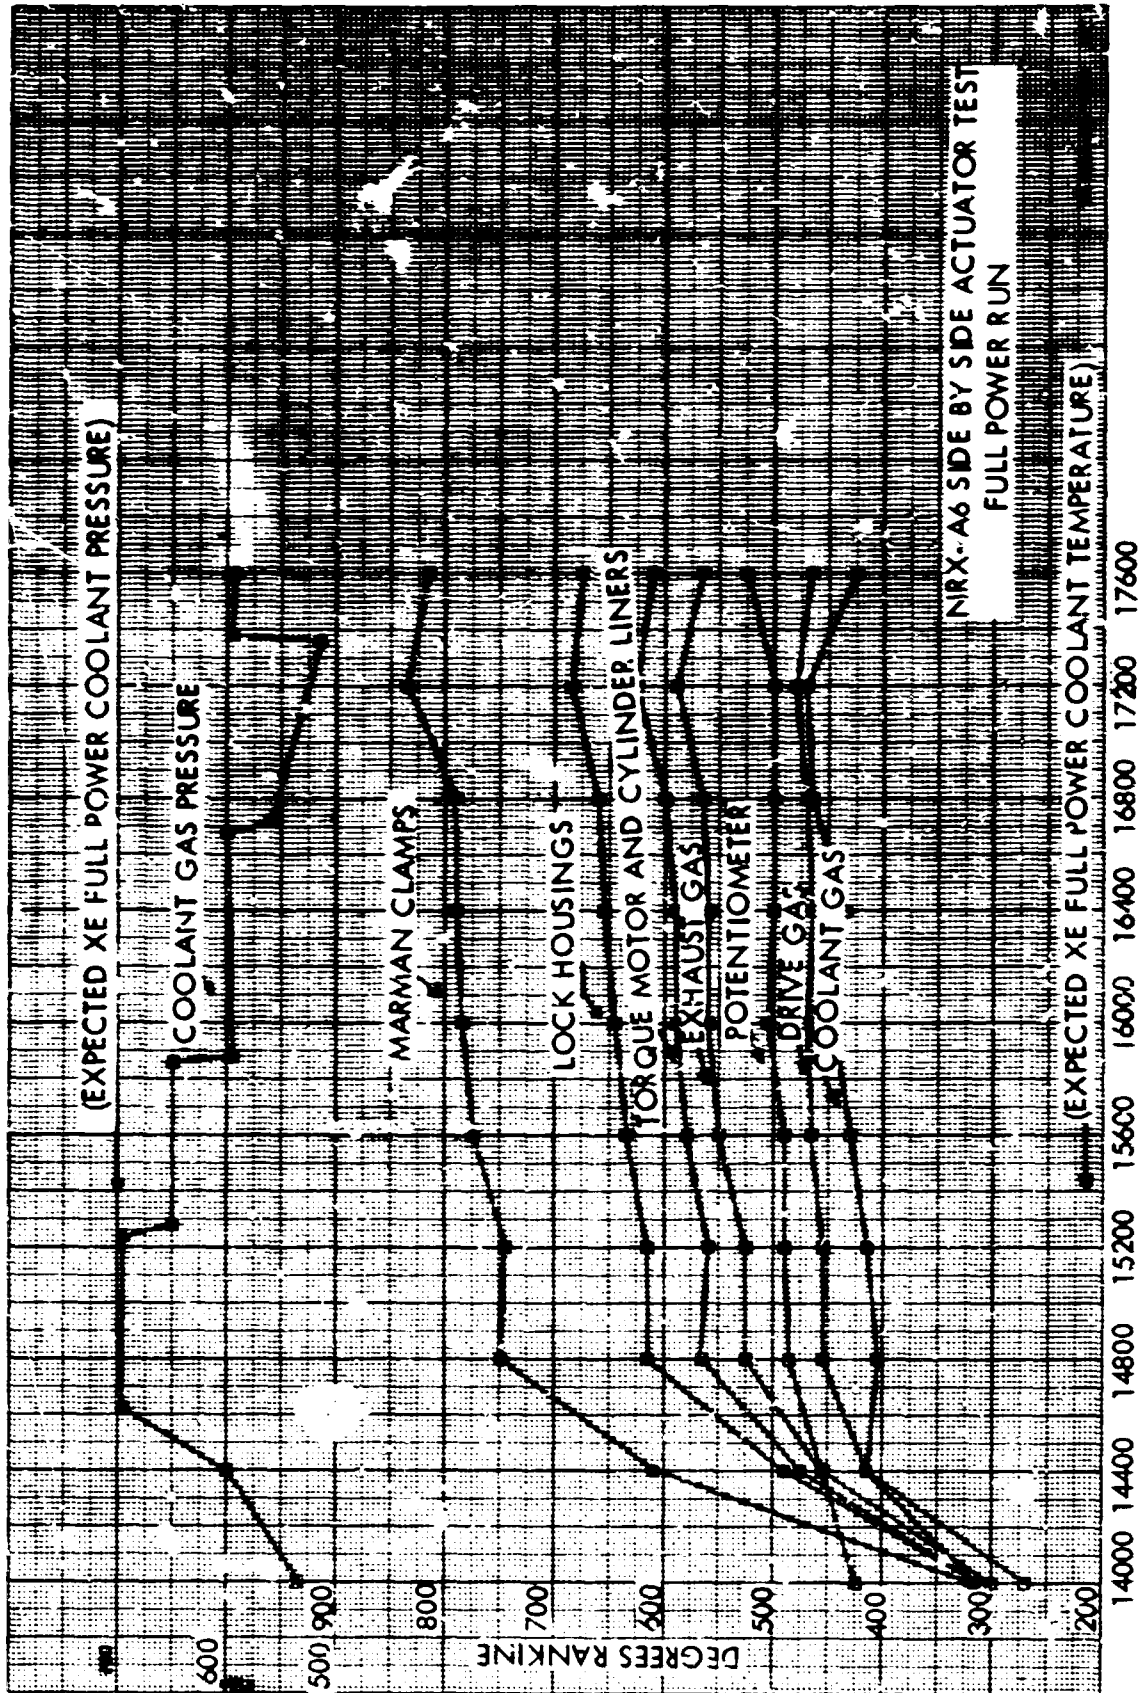
Figure 5-53. (U) NRX-A6 Side-by-Side Actuator Temperatures and Coolant Gas Pressures During Full Power Run

(U) A summary plot of actuator temperatures and coolant pressure during the reactor full power run are shown in Figure 5-53. In general, the coolant pressure was reduced in controlled increments during reactor full power operation to obtain internal temperature distribution as a function of the cooling pressure. One significant difference between this test and XE and R type tests (where the actuators will be mounted on the pressure vessel or external shield) is the coolant temperature as it enters the actuators. Coolant temperatures on XE and R tests are expected to be very near dome temperature or about 212°F at full power. The actuator side-by-side coolant temperature was on the order of 400 to 450°F. This warmup of coolant in the side-by-side test is due to the relatively long run between the LN₂ heat exchanger and the inlet to the actuator. The closely coupled

XE and R tests will eliminate this warm-up. Even with the relatively warm coolant gas temperature (450°R) and the experimentally low coolant pressures (550 psi) none of the component temperatures exceeded allowable limits. This gives strong evidence of the adequacy of the actuator coolant flow.

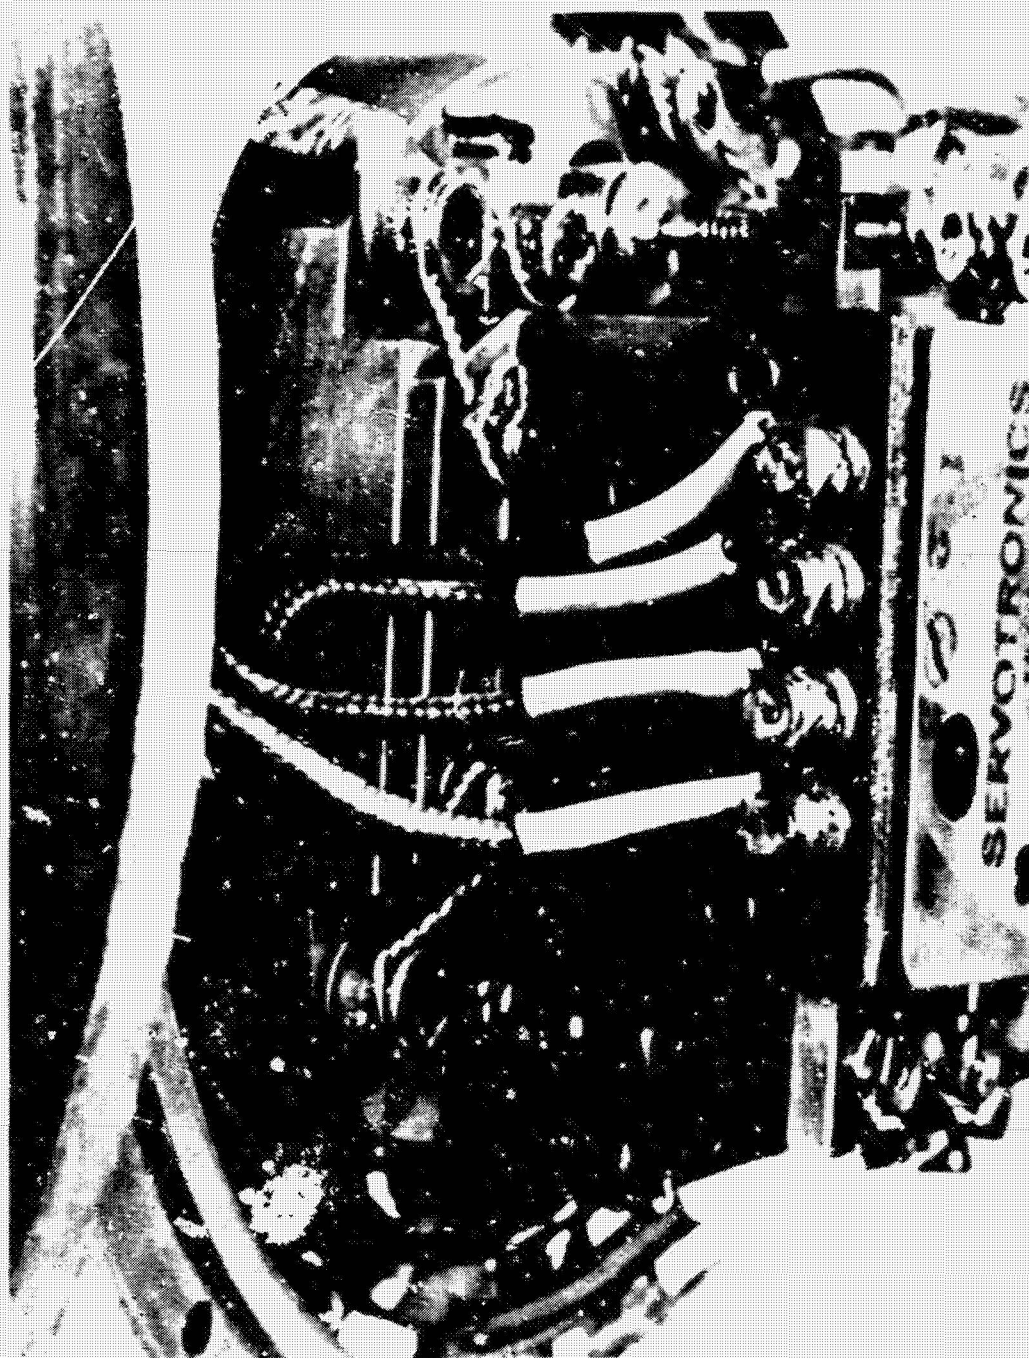
Figure 5-57. (U) NRX-A6 Side-By-Side Actuator Post Test Condition (Torque Motor, Solder Joints, Lead Wires, and Miscellaneous Servo Valve Components).

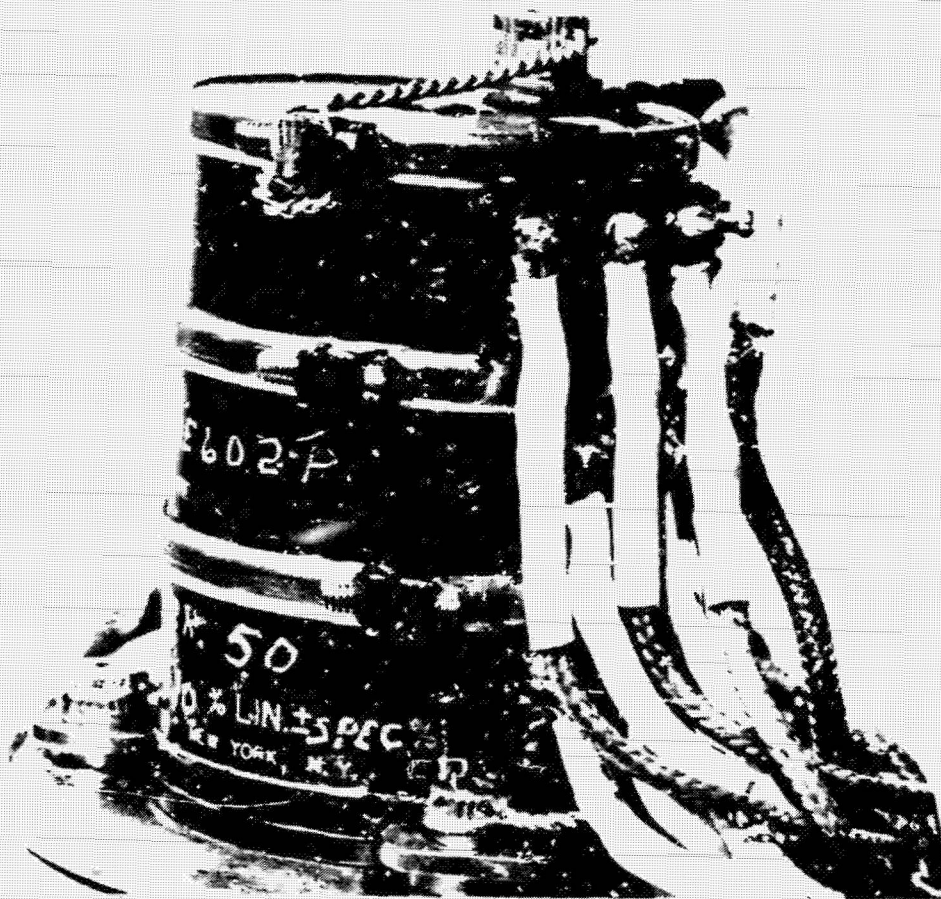
Figure 5-59. (U) NRX-A6 Side-By-Side Actuator Post Test Condition (Three Decs Pot ntiometer, Solder Joints, Wire, and Insulating Sleeves).
